Report on a Fatal Accident
and Fire at the
West London Terminal
of Esso Petroleum
Company Limited
on 1st April, 1967

H. K. BLACK, B.Sc., Ph.D., D.I.C., F.R.I.C.

H.M. Chief Inspector of Explosives

6th September, 1967

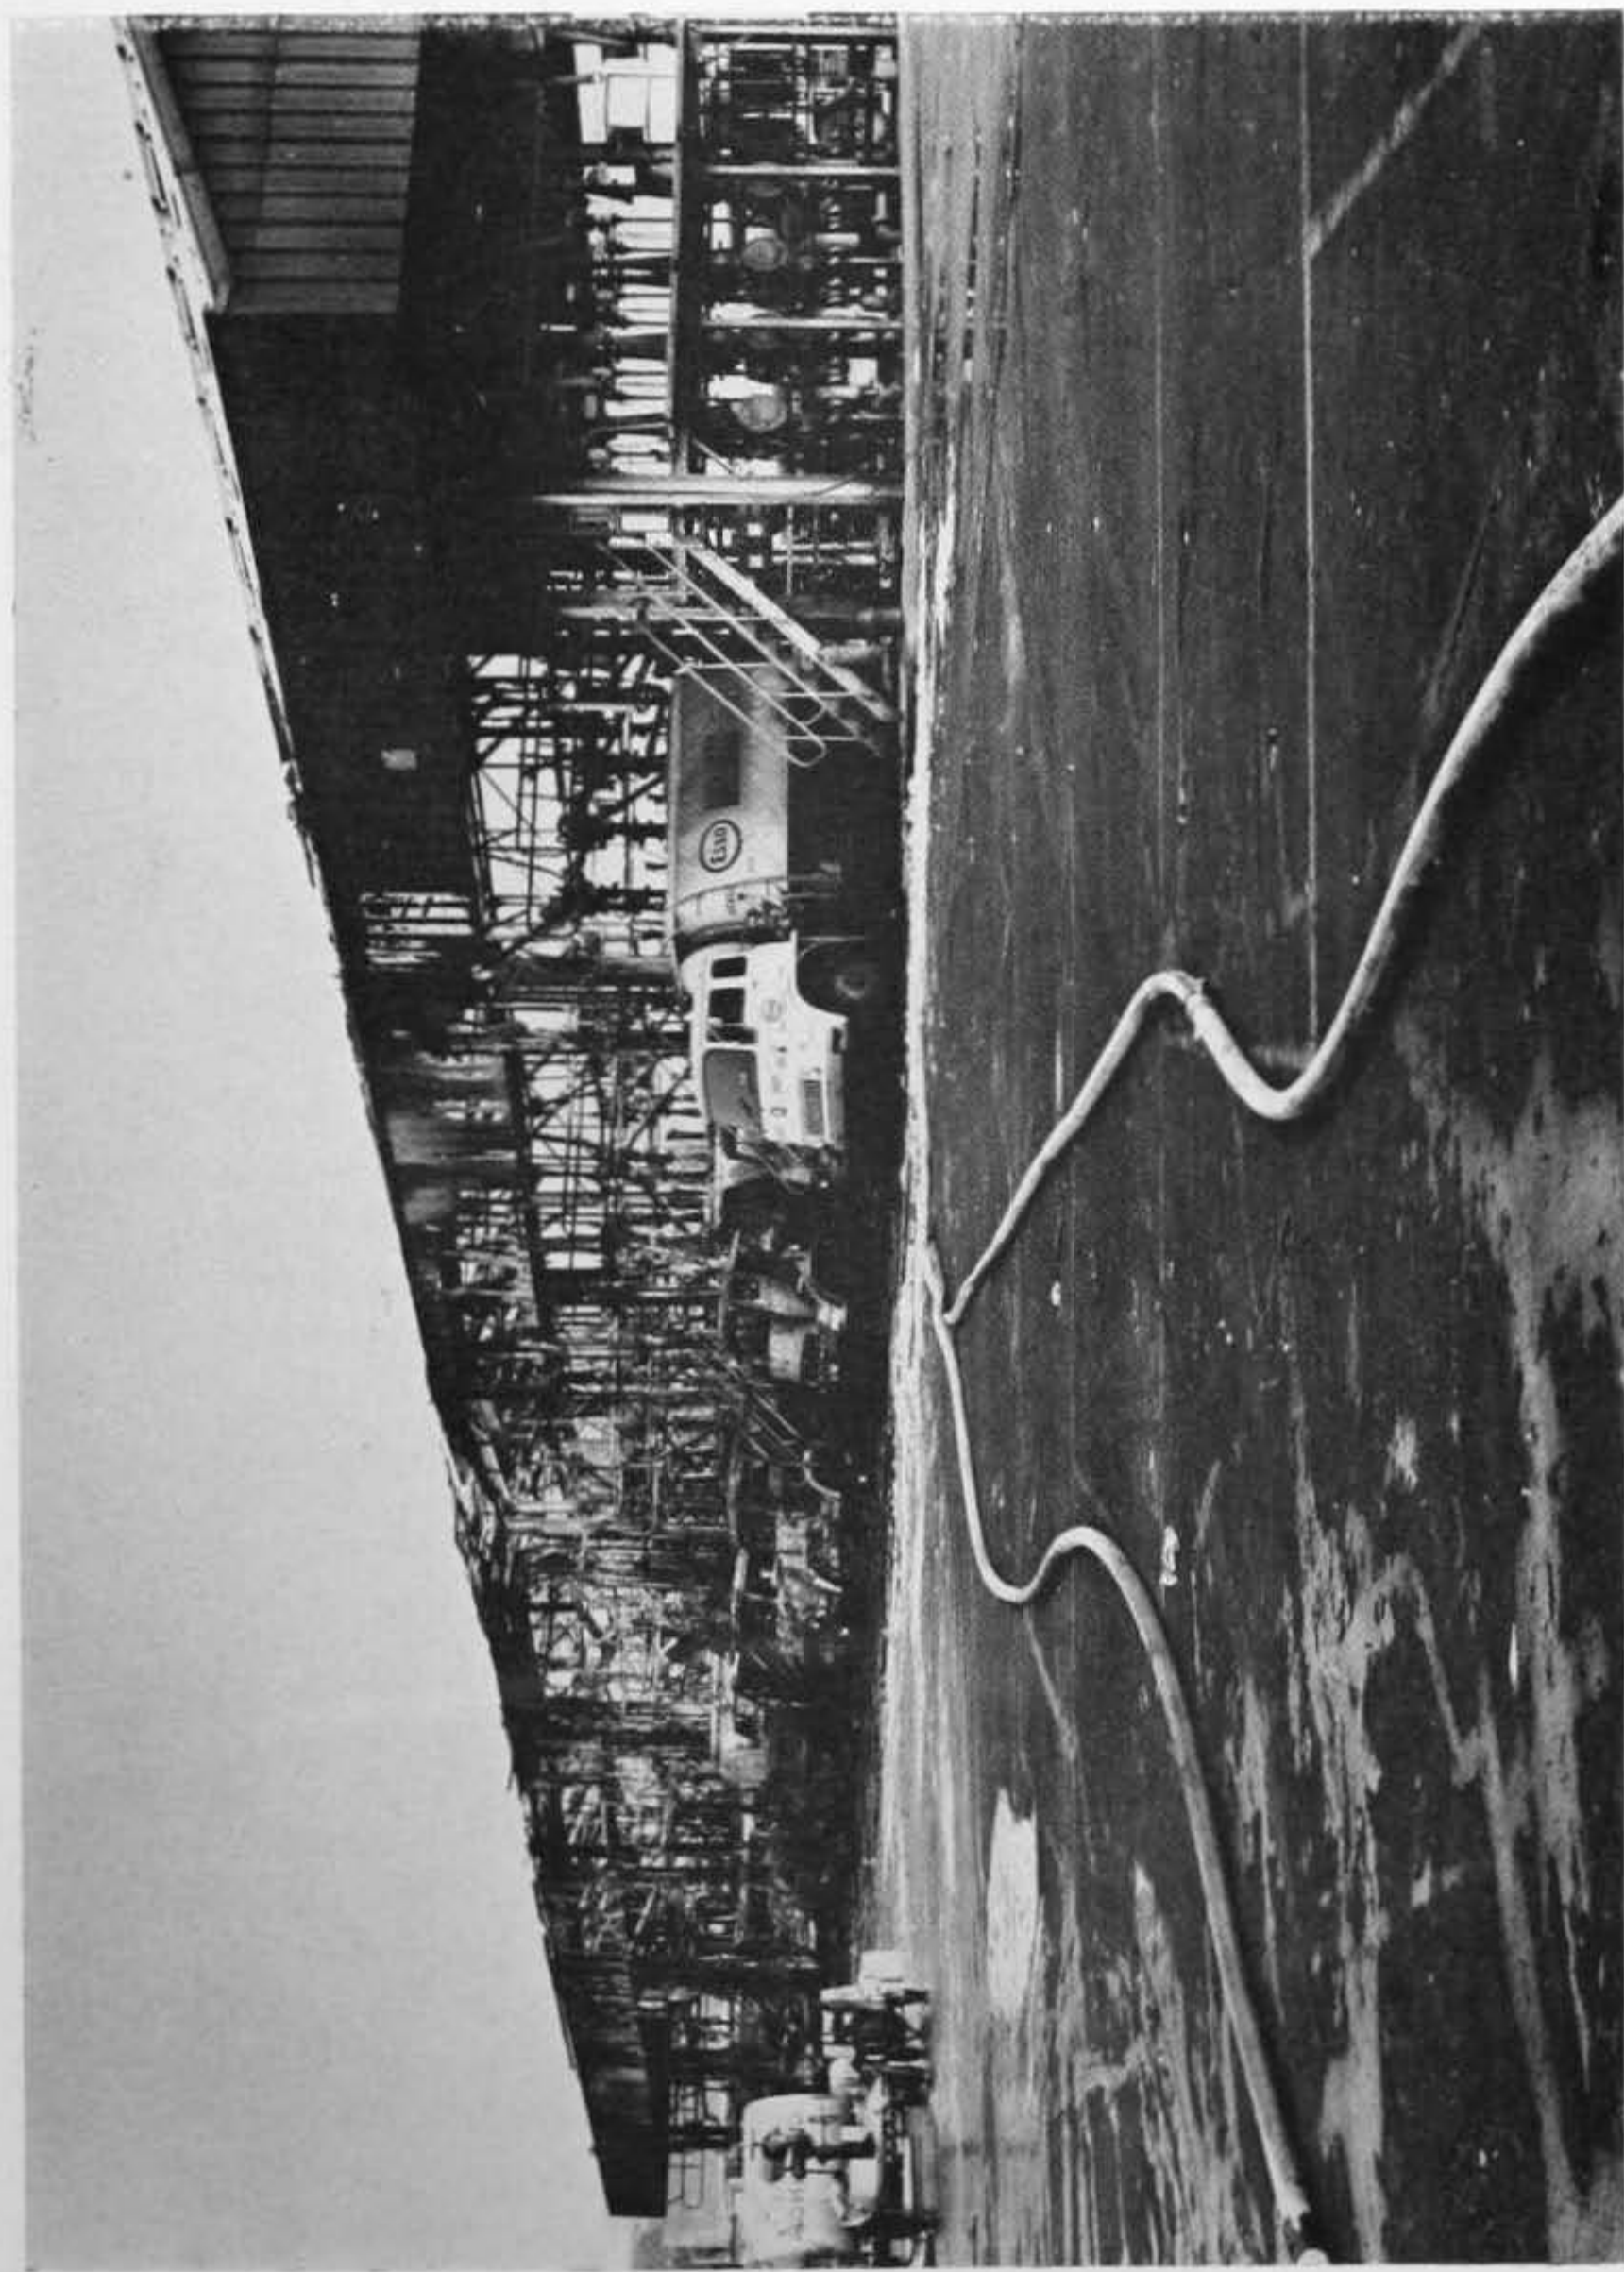
Plate No. 15

The fire and explosion caused the almost complete destruction of a line of stands used for loading road tank-wagons and, in addition, nineteen vehicles varying in size from 1,800 gallons capacity to 4,000 gallons were destroyed. The total loss has been estimated at nearly £500,000. (Plate No. 15).

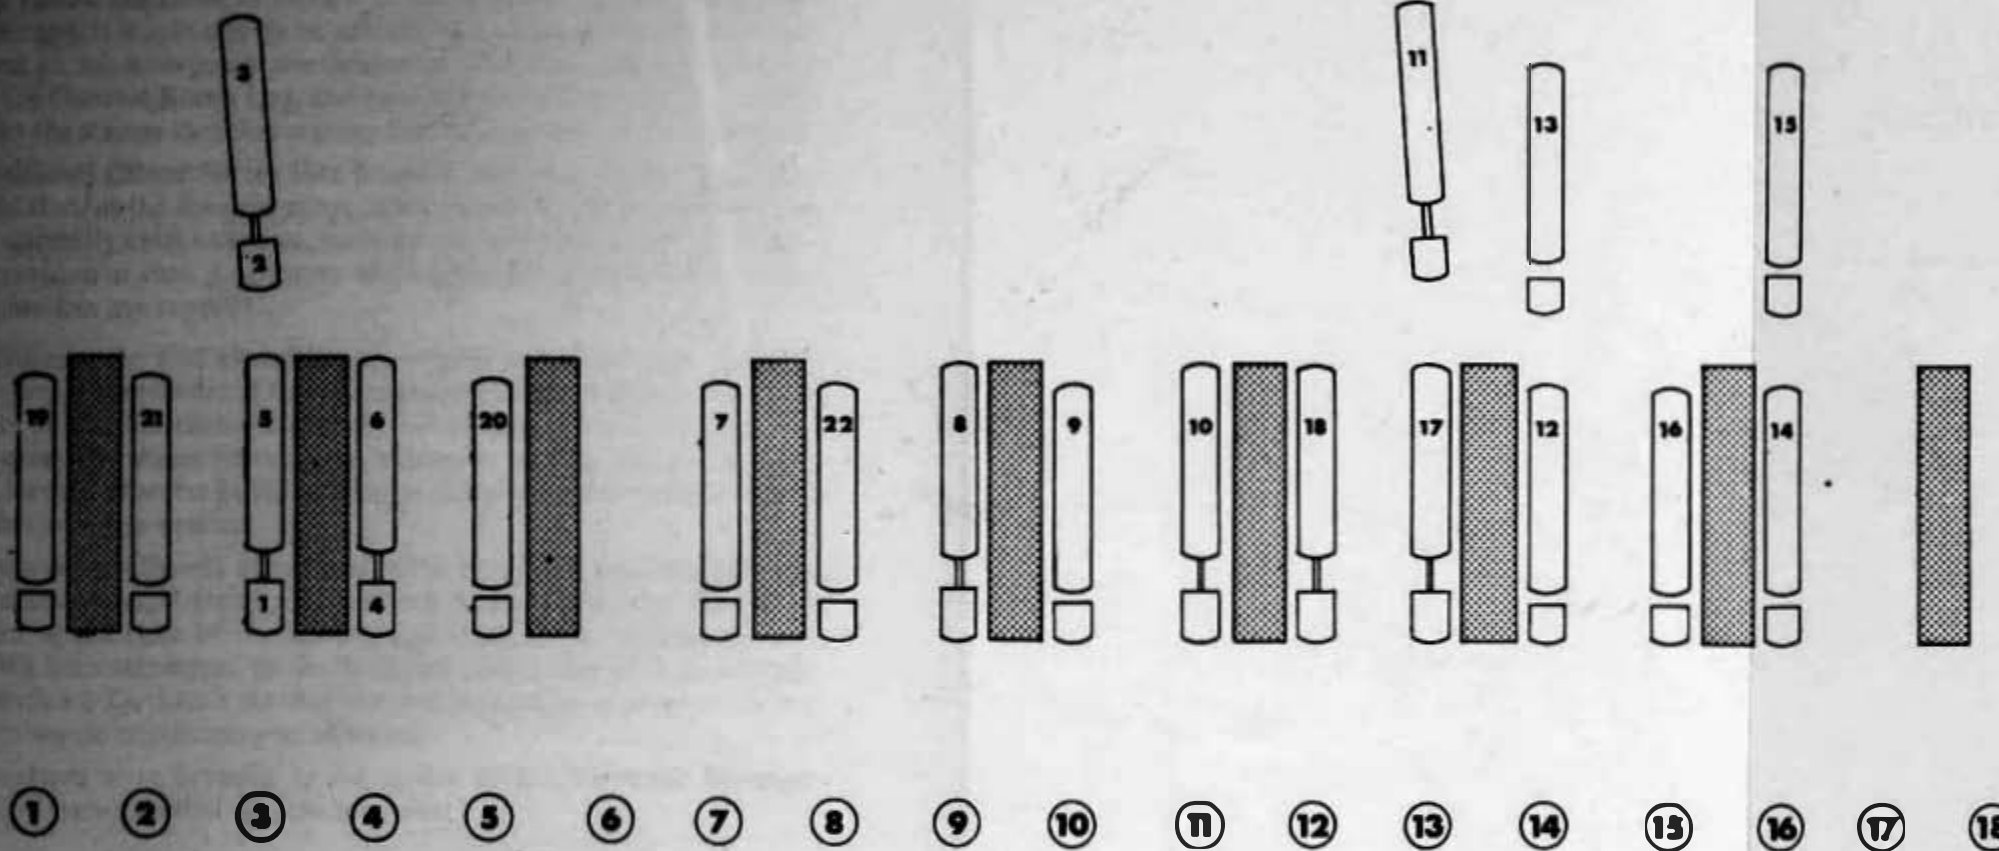
POSITION OF VEHICLES AT THE LOADING STANDS AT THE TIME OF THE FIRE

1. The numbers surrounded by circles indicate the Bay numbers.
2. The numbers shown on the vehicles indicate the Home Office ref. Nos.
3. When the fire started there were vehicles at Bays 17 and 16. However they were driven away from the area and were not damaged.
4. The vehicle indicated as standing at Bay No. 2 moved away from the Loading Area during the course of the fire and came to a stop straddling the pipe-track leading from the terminal to Esso's Perry Oaks and London Airport Central Area Depot.
